Bioretention System

Bioretention facilities are engineered facilities that store and treat stormwater by filtering it through a specified soil profile. Water that enters the facility ponds in an earthen depression or other basin (e.g., concrete planter) before it infiltrates into the underlying bioretention soil. Stormwater that exceeds the surface storage capacity overflows to an adjacent drainage system. Treated water is either infiltrated into the underlying native soil or collected by an underdrain and discharged. An underdrain system can be comprised of perforated or slotted pipe, wrapped in an aggregate blanket.

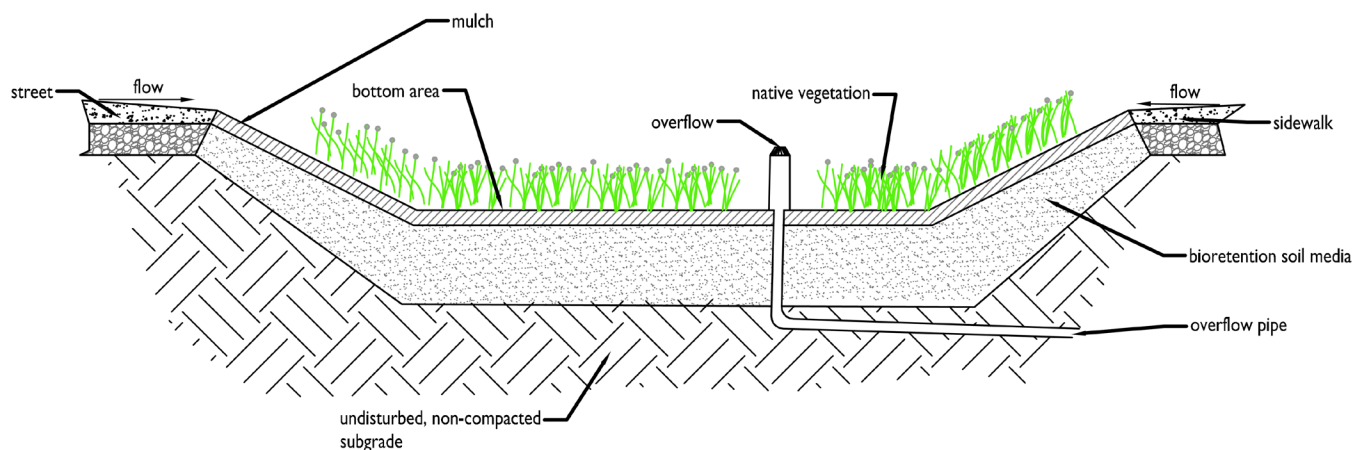
Facility objects that are often associated with a bioretention unit include:

- Inlet
- Overflow
- Underdrains (optional)
- Signage
